# Manhole Inspection Summary

Manhole # S19AA\_036MH

Insp Date: **3/11/09 2:02 PM**

**Location** Address: **W LAFAYETTE ST**

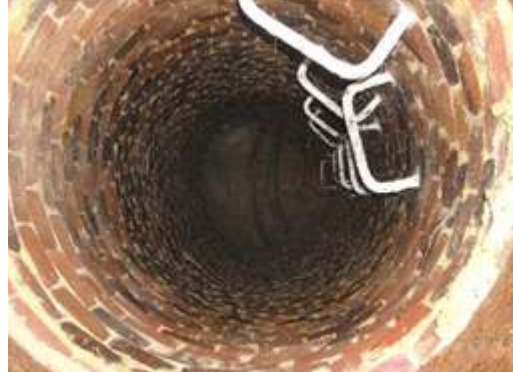
Defect 1

IS NOW BELOW GRADE, SUBJECT TO  
INFILTRATION FROM SHEETING AND  
OR PONDING. WILL BE REBURIED

WORN COVER CORRODED AND  
COVERED WITH CEMENT

Comments **LOCATED BURRIED BENEATH LAFAYETTE ST BRIDGE. EXPOSED USING HAND TOOLS. OPENED USING 16LB MAUL AND PICKAXE. INSPECTION COMPLETE. MH NEEDS TO BE RAISED TO PREVENT BEING BURRIED AGAIN DUE TO EROSION OF SOIL IN VICINITY.**
